**Washington State Ferry Terminal
Structural Inspection**

Seattle Ferry Terminal

Location	Bridge No.	Type	Inspection Date	Report Received
Slip 3	519/100FT	Routine, FC, Special	6/23/2020	9/23/2020

BRIDGE INSPECTION REPORT

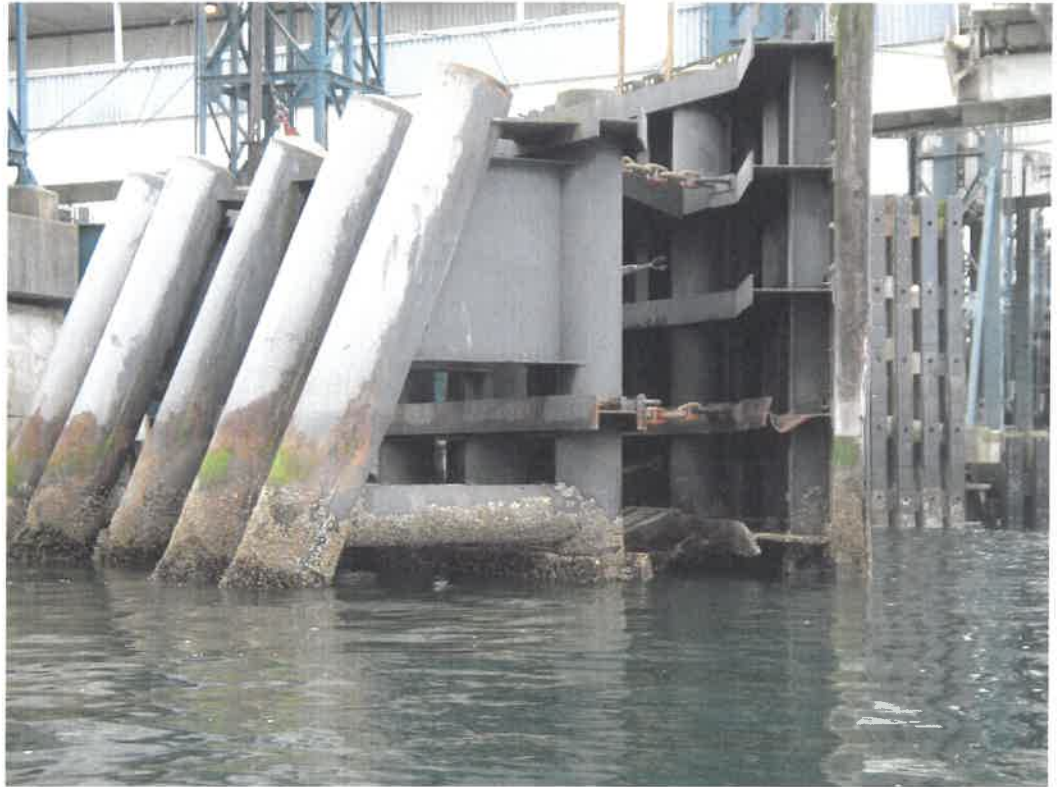
Two steel waler ends on the right wingwall outboard have been damaged by impact. These walers are located in the 4th and 5th tier down. The waler webs are buckled/bent 3" out of plane and the flanges are twisted out of plane over the end 3 feet (Photo #105)(CS3).

Outboard end of right wingwall has bent and crippled walers at level 4 & 5 down.

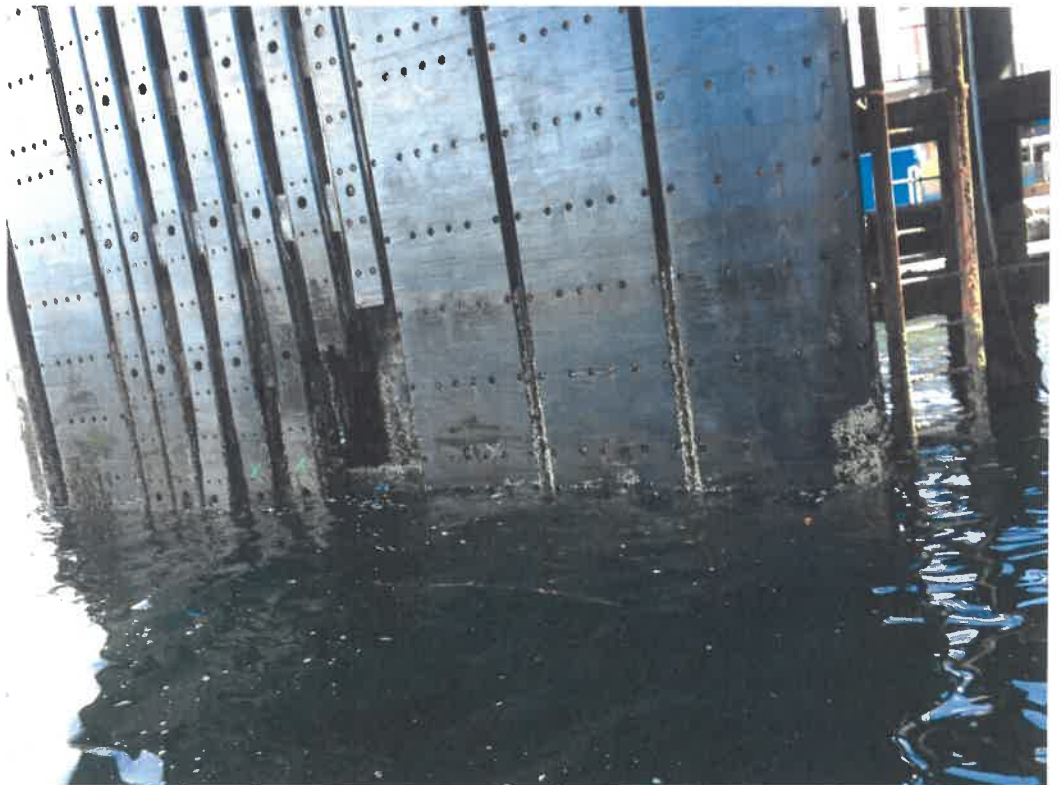
SI-139

Several facing timbers are rotten, with lower portion missing from two of them (Photo #139)(CS3).

Rotten facing timbers in right wingwall.

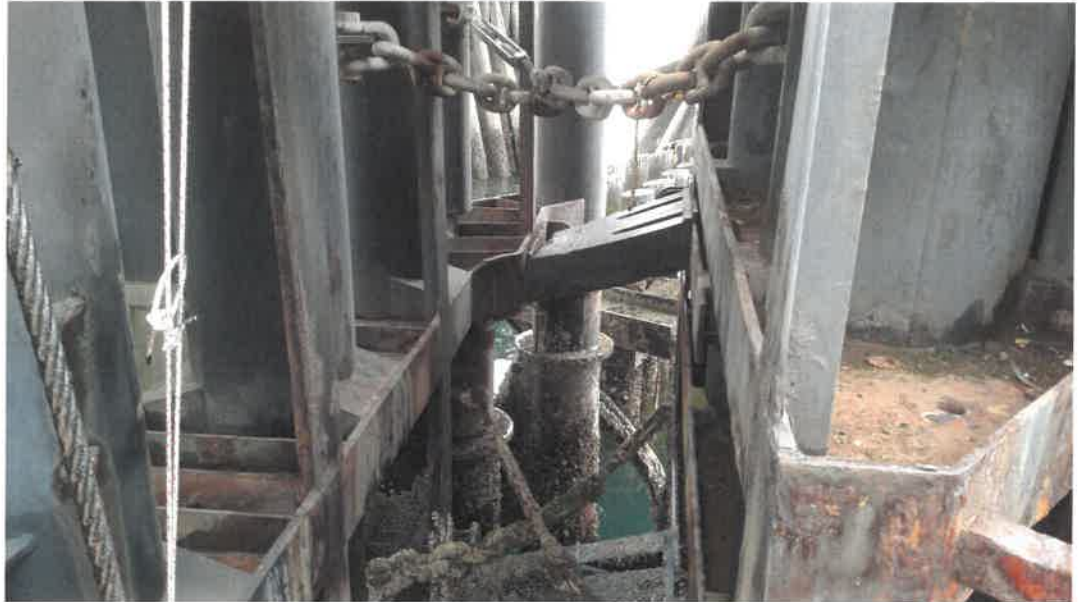
SI-133

Lower trelex fender between pile walls is loose (Photo #133).

8451 Steel Pile Frame Wingwalls
Photo Type: G - General
Orientation: Sea
Date: 6/25/2018
Repairs:
Loose trellex fender in the left wingwall.

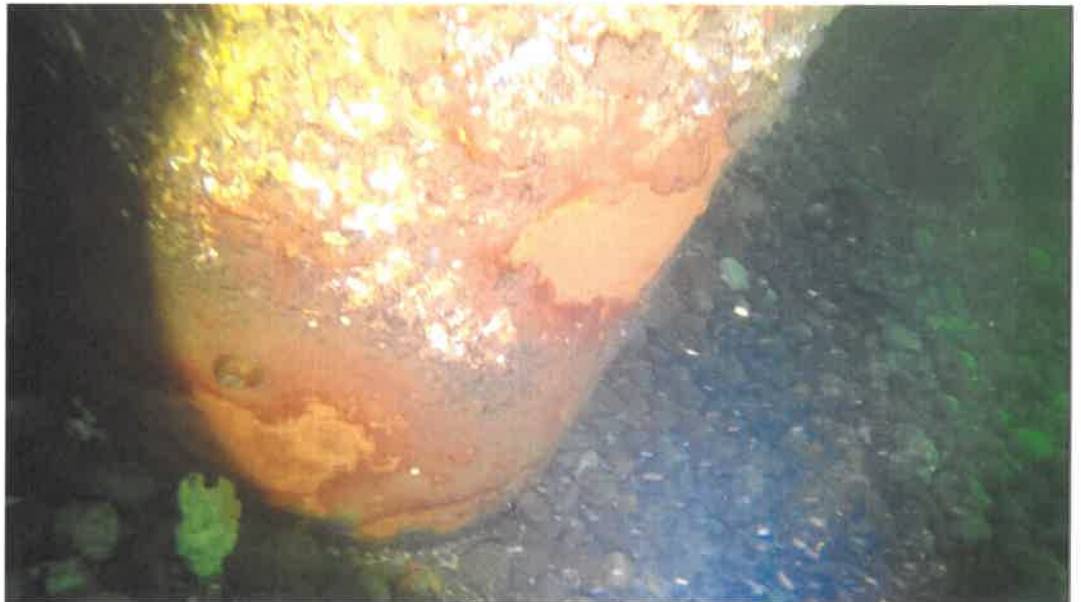
UW-4

8451 Steel Pile Frame Wingwalls
Photo Type: I - In Depth
Orientation: Sea
Date: 7/10/2017
Repairs:
Left Wing Wall Pile 1D has a 2' band of coating failure with corrosion.

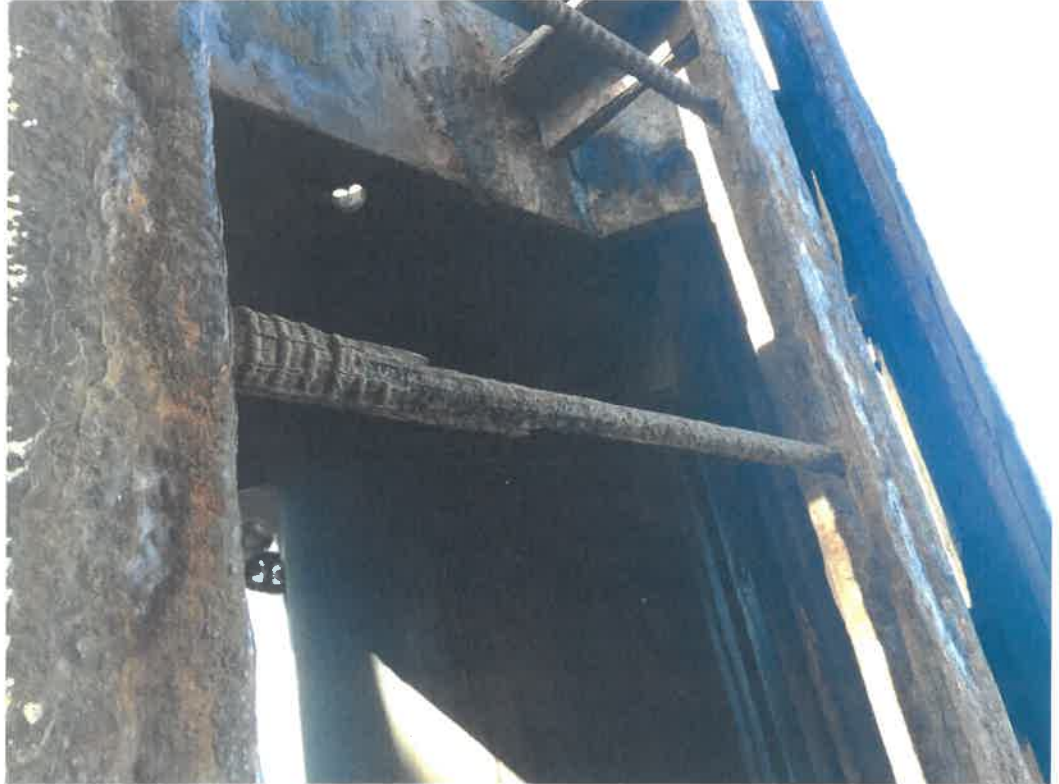
Wingwall ladders have deteriorated paint and are heavily rusted in the intertidal zone (Photo #140) (CS3).

Left wingwall ladder rungs have section
lose from corrosion, right wingwall ladder
is similar.
